## **Copernicus EMS Activation: EMSR558 Volcano eruption in Tonga**

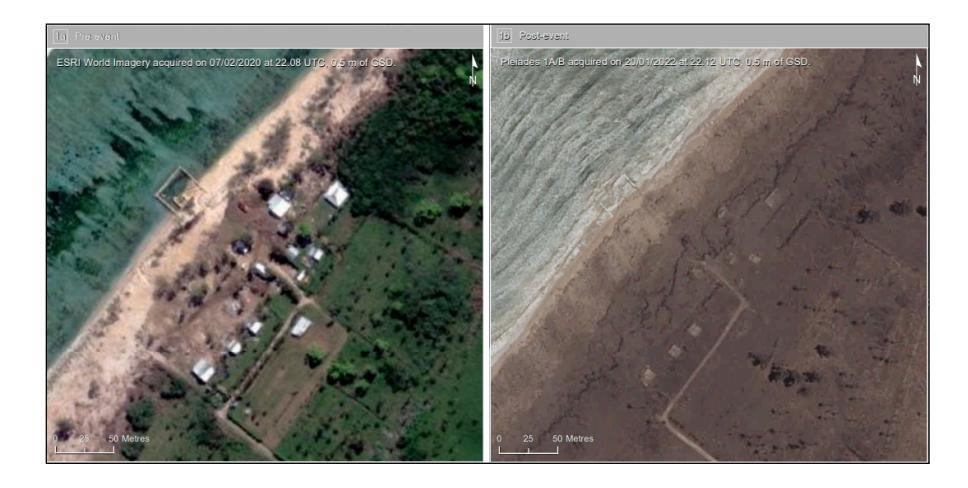
Fig. 1. A sample of comparison of pre and post event images analyzed during the EMSR558 production in Tonga.

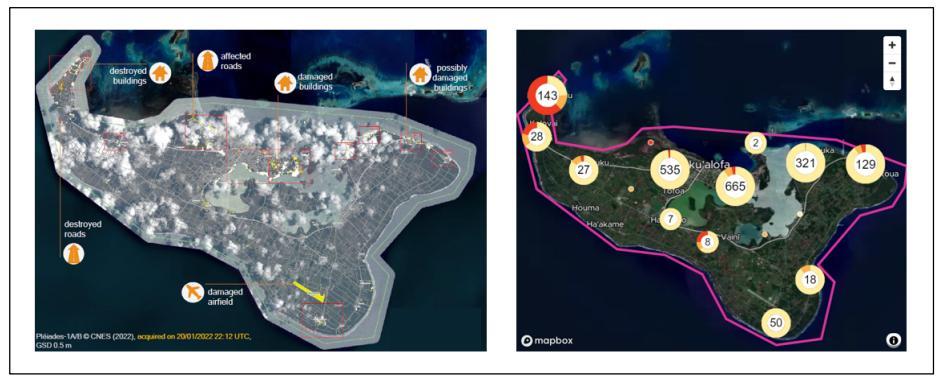
The analyses revealed an ash deposit concerning the entire ground surface on the AoIs, 27406 ha and 4006 ha, for Nuku Alofa and Lifuka, respectively. The total number of people affected by the event was estimated 77794 in the AoI01 (corresponding to 98% of the residents) using the Global Human Settlements (GHS) population density dataset. The damage grading analyses indicated that 131 buildings were assessed as destroyed, 87 as damaged, and 1719 as possibly damaged. The road network was also subjected to extensive damage, with 5.8 km classified as destroyed, 25 km damaged, and 31.7 km as possibly damaged. The damage concentration in the AoI01 is represented in the Fig. 2 below.

**Fig. 2.** A more straightforward representation of the damage concentration in AoI01 in Nuku Alofa. On the right, the red portion of the pie chart corresponds to the destroyed structures, whereas the orange represents damaged and the yellow is for the possibly damaged ones. The numbers illustrated in the center of the charts correspond to the Total Affected with the sum of destroyed, damaged, and possibly damaged structures.

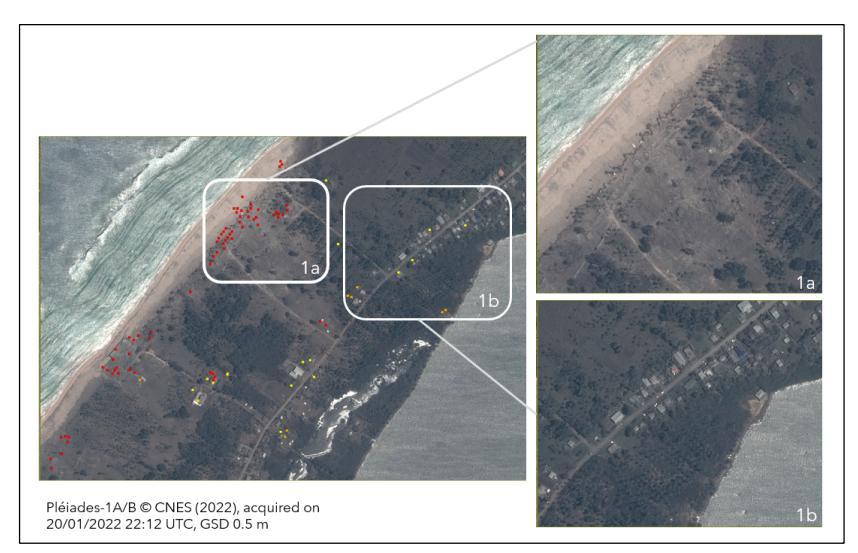
Fig. 3. Comparison of the damage concentration in the NW coast of the Tongatapu island (open-water side of the NW coast vs. inner side)

The damage assessment allowed the analysts also to hypothesize the direction of the tsunami waves hitting the Tongatapu island. Tsunami waves were inferred to initially hit the island's Northwest coast facing the open water considering the local high damage concentration (Fig. 3). However, the inner side of the NW coast seemed to have significantly reduced damage as the buildings remained almost intact.

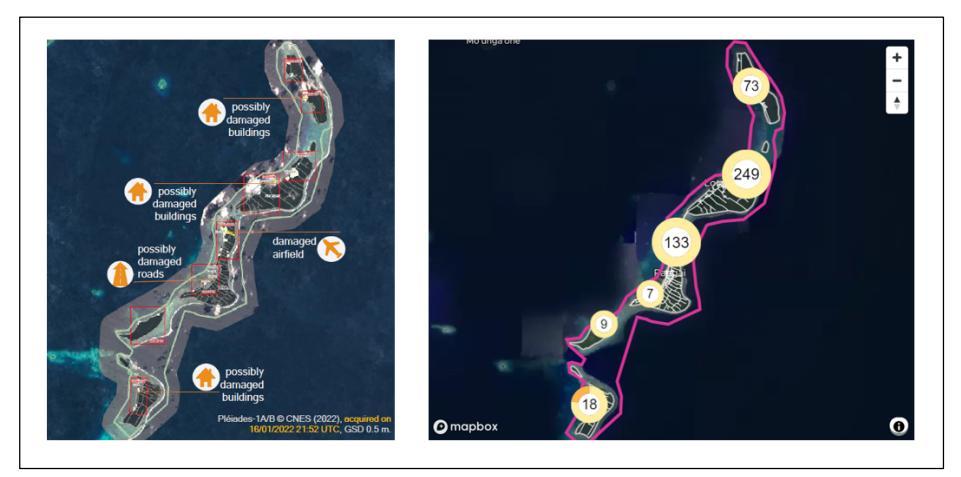
Regarding the AoI02, it was estimated that 4482 people (corresponding to 87% of the residents) were affected by the disaster. The grading assessments classified 4 buildings as damaged and 485 as possibly damaged. The damage concentration in the AoI02 is illustrated in the <u>Fig. 4</u> below. In this case, 0.1 km of roads were detected as damaged and 2.5 km as possibly damaged. In addition, both the airports present on the island were revealed to be entirely covered by ash deposits; therefore, they were presumed not to be in a fully operational state.

**Fig. 4.** A more straightforward representation of the damage concentration in AoI02 in Lifuka. On the right, the orange portion of the pie chart corresponds to the damaged structures, whereas the yellow represents the possibly damaged ones. The numbers illustrated in the center of the charts correspond to the Total Affected with the sum of damaged and possibly damaged structures.
